Changing the side grid and the nuts

Models affected

Production until march März 2018 and until serial number TP182*

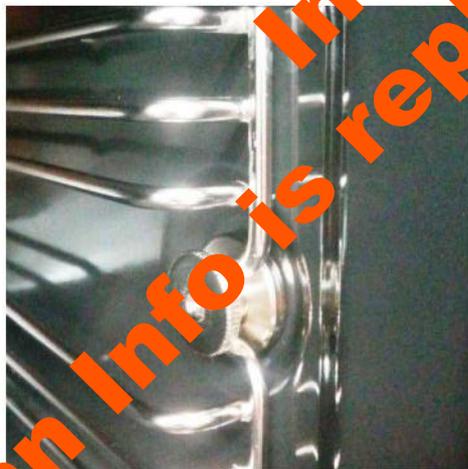
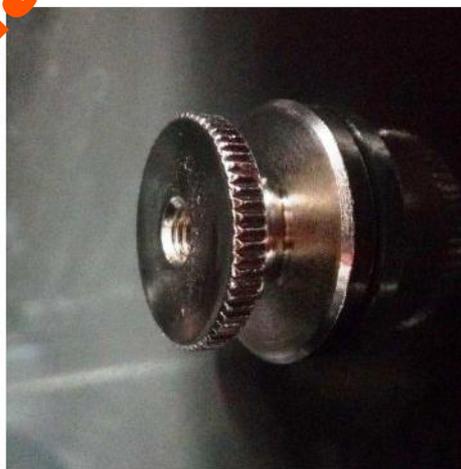
Chromed support nuts (it can be easily identified by the knurl of the nut)

On appliances before TP182, the two side grids and the corresponding fixing nuts - if not already done - must be replaced.

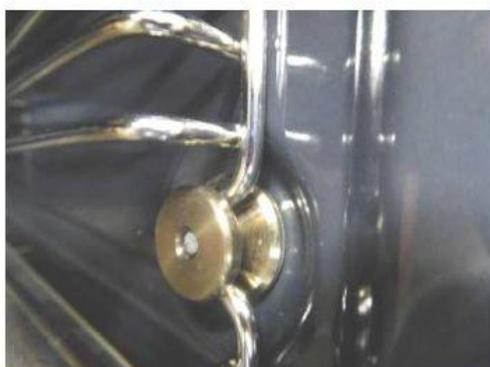
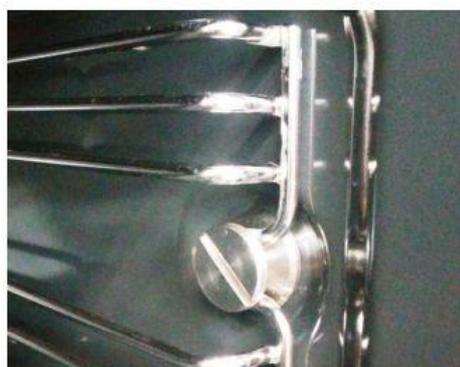
Stainless steel support nuts (two versions available/without and with groove)

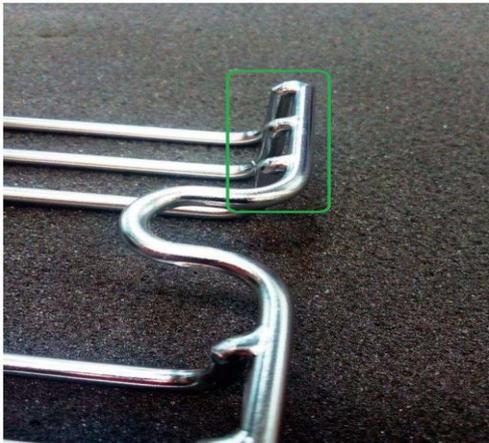
OK: round edges

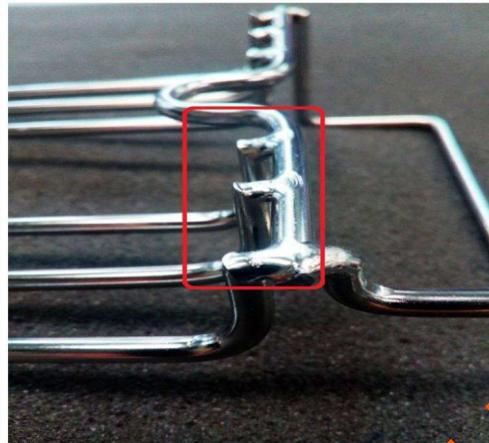
not OK: sharp edges

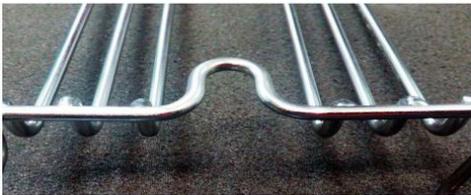
OK: flat surface in contact with the cavity

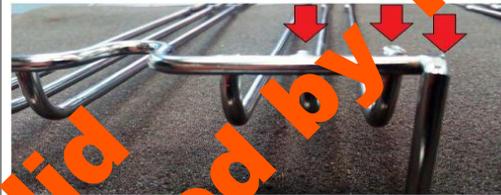
not OK: sharp projections

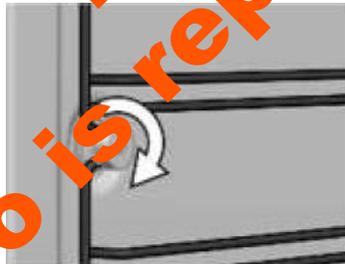
The side rails must be firmly screwed in with the lock nuts, otherwise they could damage and/or overheat.
